2011/2012 Annual Inspection Report

Replace Sabine Refuge Water Control Structures at Headquarters Canal, West Cove Canal, and Hog Island Gully (CS-23)

State Project Number CS-23
Priority Project List 3

December 01, 2011
Cameron Parish

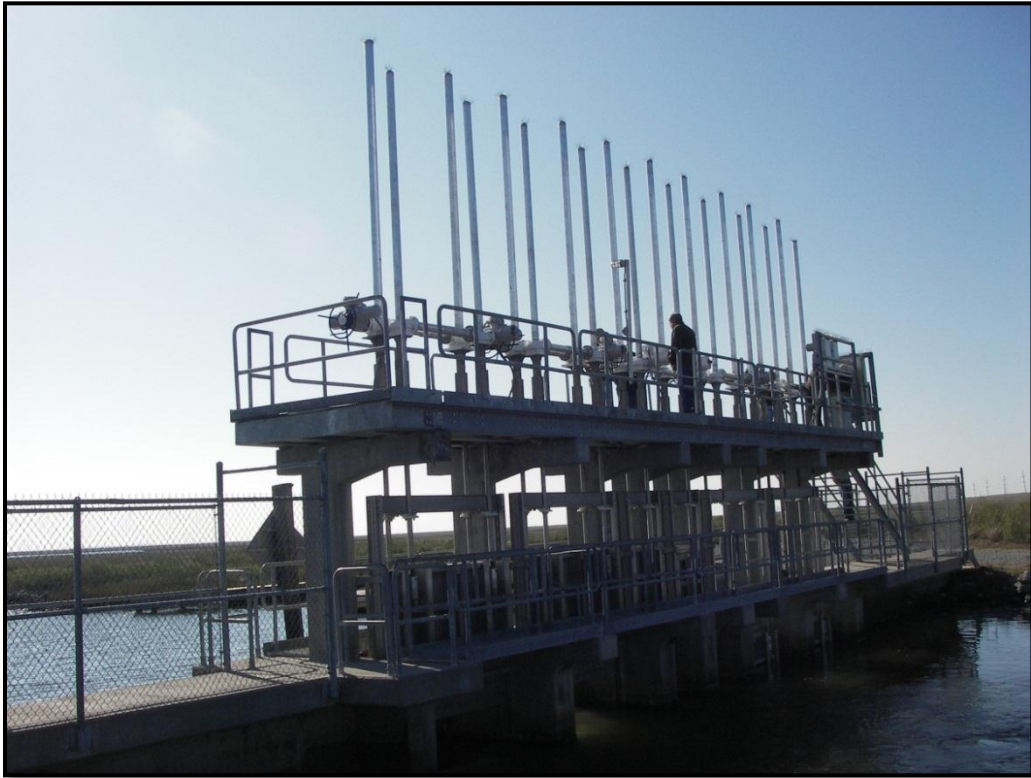
Photo No. 1, Hog Island Gully Structure

The structure is in fully operational condition as a result of the recently completed maintenance event. The conversion from single to dual stems appears to have helped with the operation of the gates. (Photos: Appendix B, Photos 1 - 2)

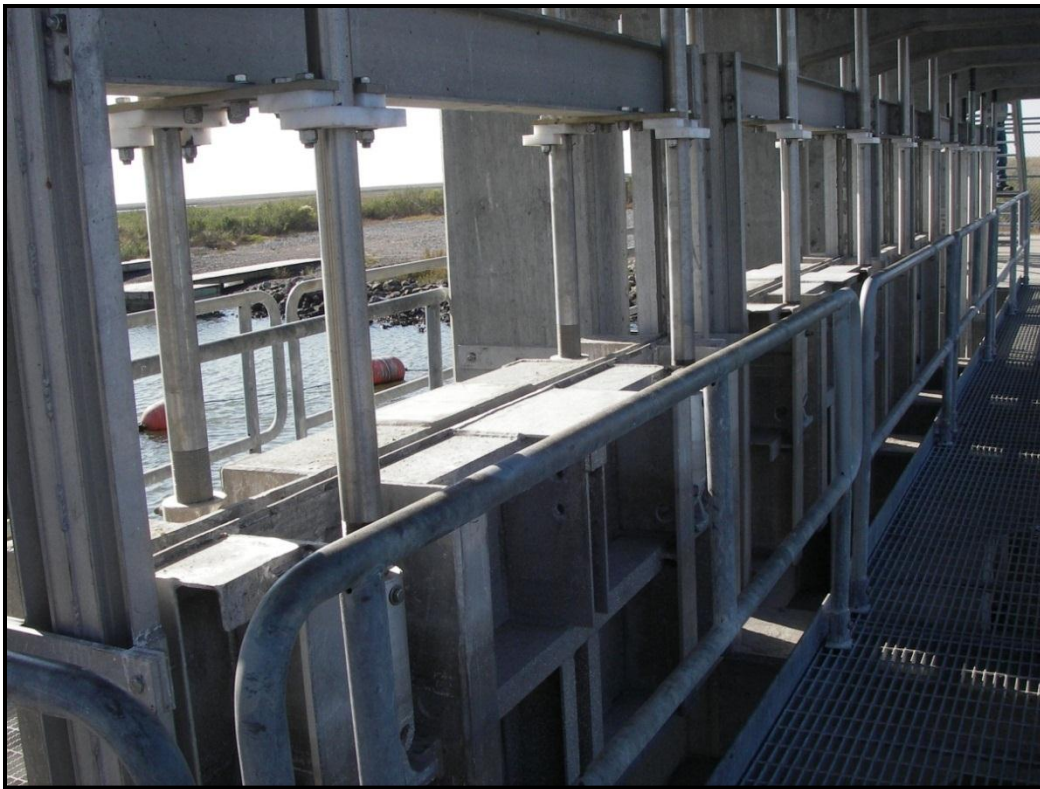
Photo No. 2, Hog Island Gully Structure – new dual stem configuration

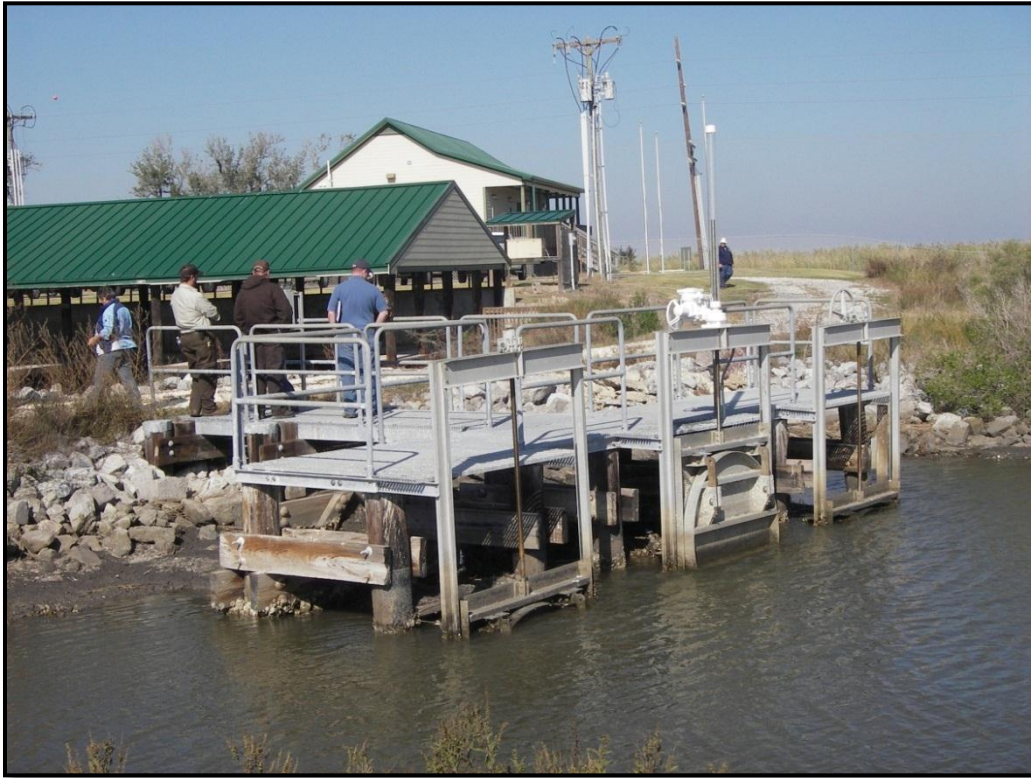
Photo No. 3, Headquarters Structure

The structure is in fully operational condition as a result of the recently completed maintenance event. (Photos: Appendix B, Photos 3-4).

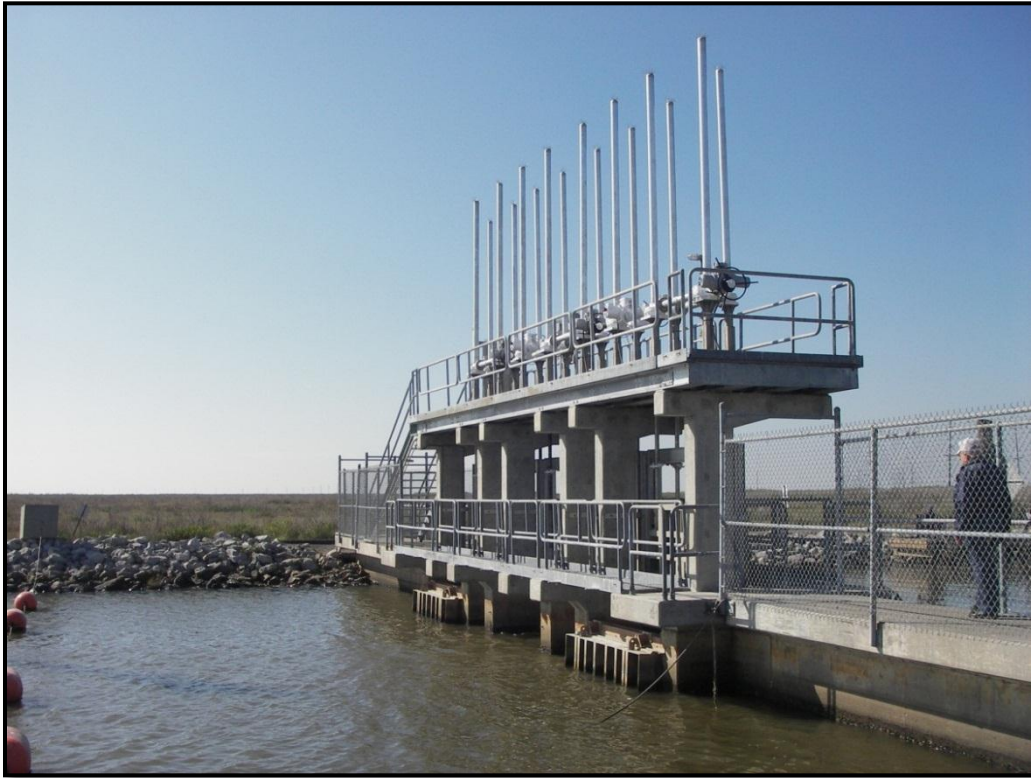
Photo No. 5, West Cove Canal

The structure is in fully operational condition as a result of the recently completed maintenance event. The conversion from single to dual stems appears to have helped with the operation of the gates. (Photos: Appendix B, Photos 5-6).

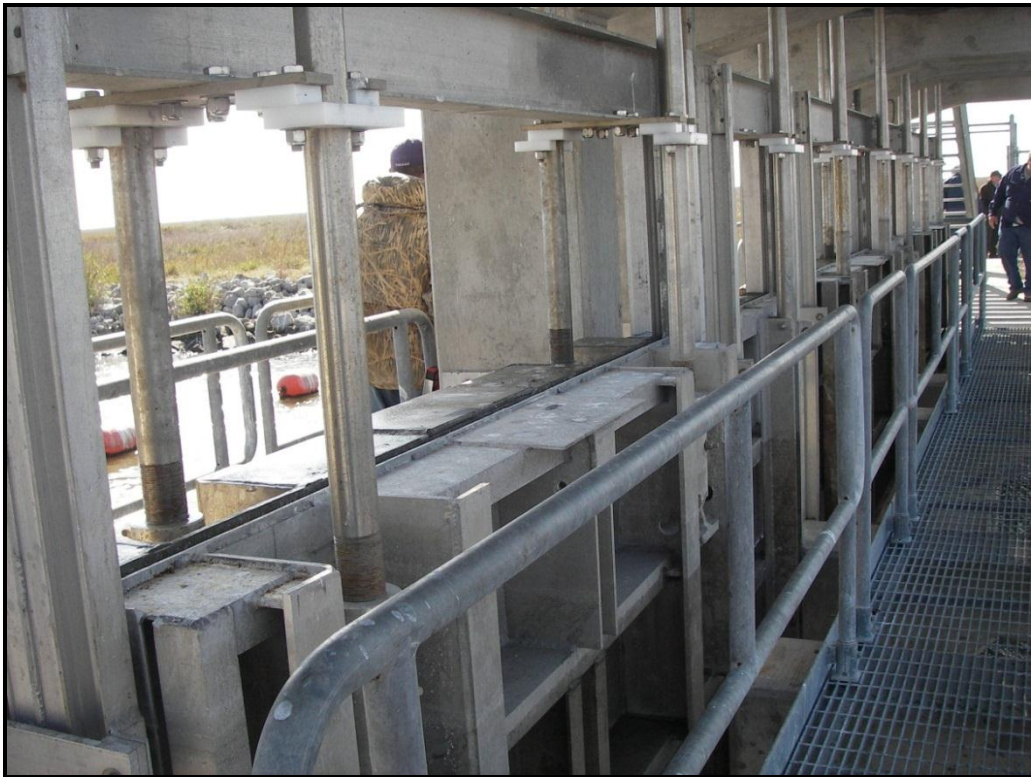
Photo No. 6, West Cove Canal – new dual stem configuration
